**Examples of Effective Applications**

1. **Below: Sunburst Push Cart; NOW AVAILABLE** - \$695 plus shipping.

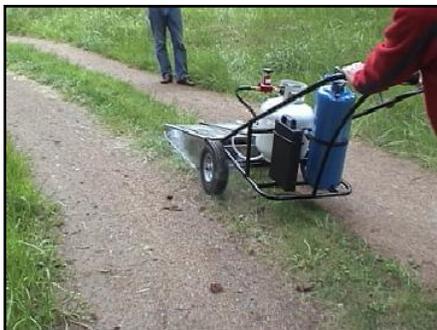
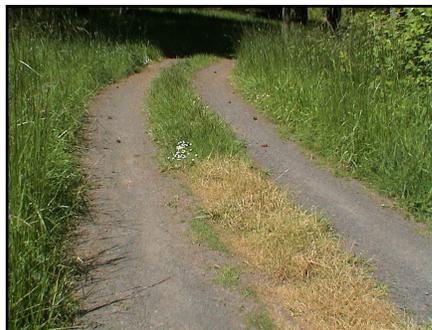
**Left:** late stage prototype in use. **Right:** established grasses 2 days after 1 treatment. (Ave. rainfall +/-40" per yr.)

Suitable for spot weed control or where maintenance areas are relatively small (e.g., driveways, paths, gravel areas).

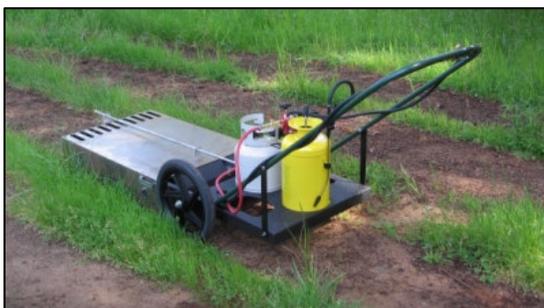
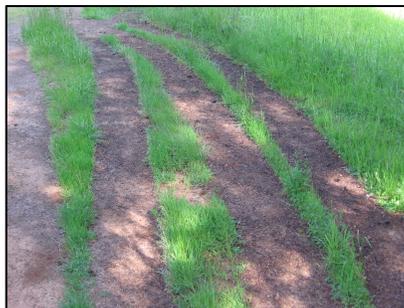
**Below: Left:** Current commercial model at 2007 trial plots. **Right:** 2007 trial plots in May.

Note untreated strips of dense sod between treatment areas.

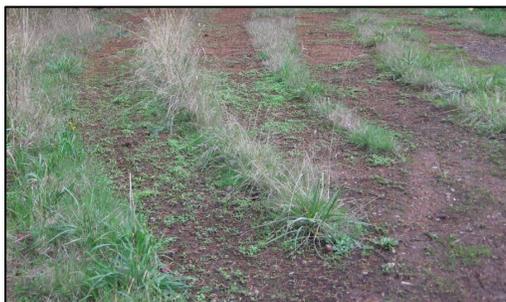
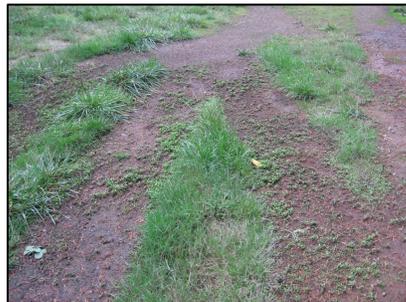
**Below: Left and Right:** 2007 trial plots in October (no treatments since May). Newly germinated seedlings after fall rains are easily killed with one treatment.

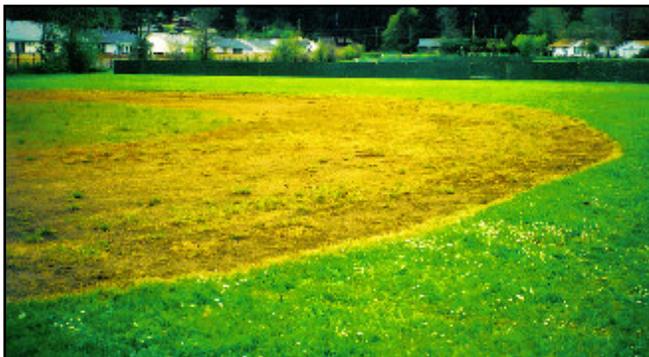
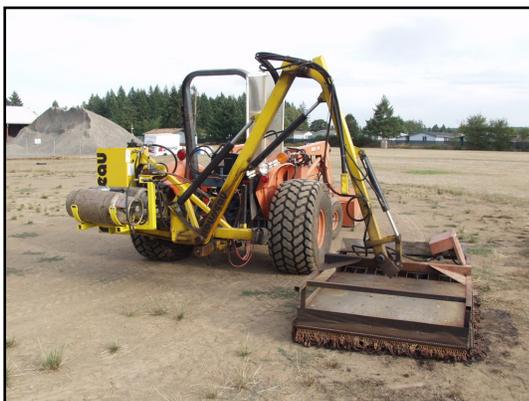
2. **Below:** Baseball Infield (Veneta, Oregon; 10 miles west of Eugene; ave. rainfall +/- 40" per yr.)

**Left:** dead seedling grasses and damaged perennial weeds 1 week after 1<sup>st</sup> treatment, early April. Note green "control" area (temporarily untreated) in center of field – area received delayed treatment to highlight impact of initial application of Sunburst equipment.

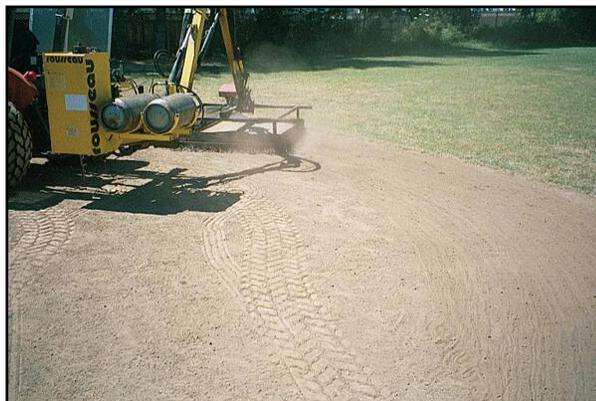
**Above:** Sunburst's original boom mounted unit (4'x5') attached to a 55 HP tractor; beginning 3rd treatment to continue removal of well-established grass clumps.

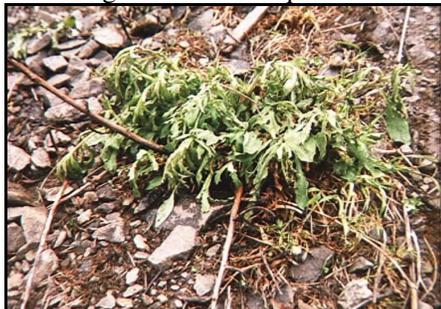
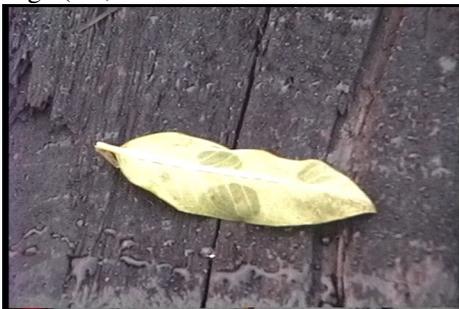
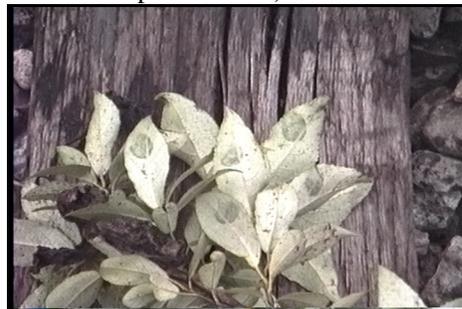
3. **Below:** Examples of weeds immediately after treatment. Appearance of a fingerprint when leaves are pressed between a thumb and forefinger indicate adequate tissue damage (i.e., treatment is sufficient to cause death of the plant tissues).

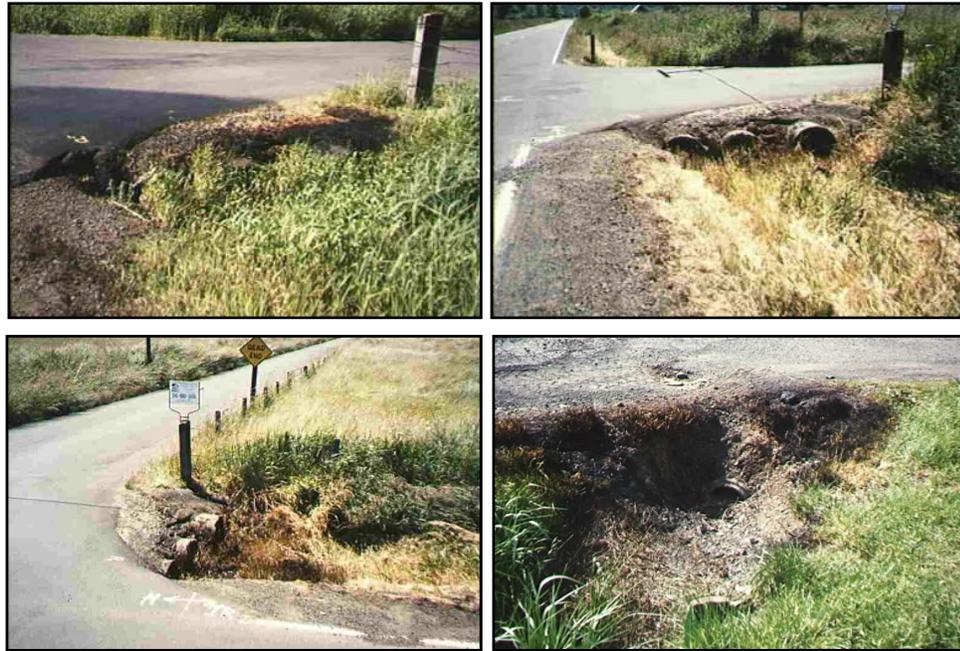
4. **Above** – culvert openings freed of dense grass to facilitate the flow of water & to provide improved visibility for implementing ditch maintenance operations that might damage hidden culvert openings (e.g., ditch pulling near the culvert openings). Above results are from 3-4 treatments of dense vegetation (e.g., Reed Canary Grass). With routine application of **Sunburst** equipment, *plant growth can be significantly inhibited while also maintaining a living sod, providing multiple benefits:* reduced use of herbicides in water channels, maintenance of optimum flow capacity, reduced clogging of culvert openings from collected debris; helping prevent overflows and erosion damage, clear visibility for maintenance operations around the culvert openings. (Ave. rainfall +/- 60” per yr.)

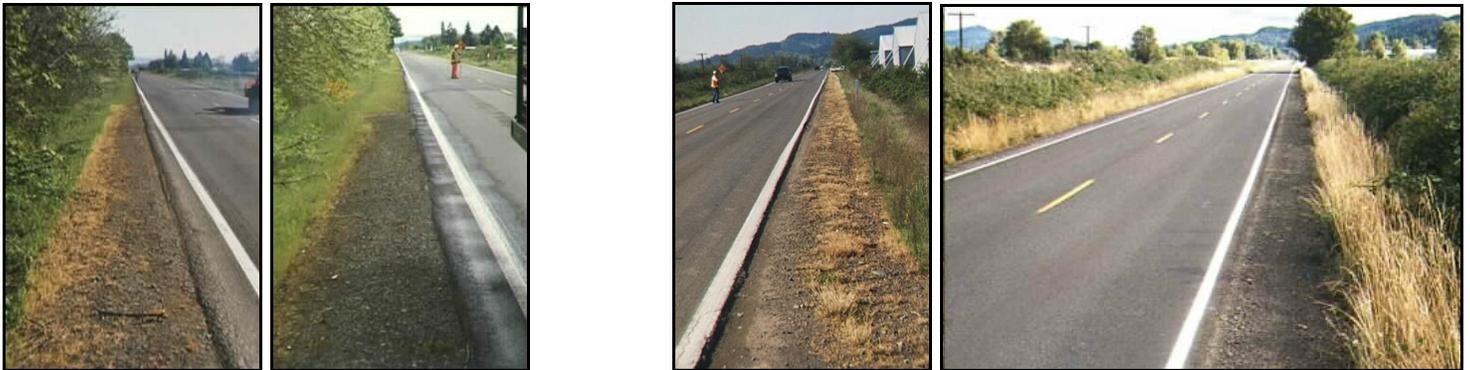
5. **Below:** Road Shoulders (Route 99 between Eugene and Cottage Grove, Oregon). (Ave. rainfall +/- 40” per yr.)

- a. **2 Photos at Left** (same site): 10 days after 1<sup>st</sup> treatment in April (left) and immediately after 2<sup>nd</sup> treatment (right); seedling weed growth is an ideal condition for use of **Sunburst** equipment.
- b. **2 Photos at Right** (same site): 10 days after 1<sup>st</sup> treatment in April of moderately dense, well established weeds (left), and after six applications (right; late June) - well established weeds require several treatments to eradicate them; **Sunburst** recommends pulling and blading of shoulders with these conditions, or treatment with herbicides, to remove the existing weed population; timely applications with **Sunburst** equipment the following Spring (as in the photos on the Left) will then control shoulder weed development with a minimum number of treatments (typically, 1-4 times per year depending upon site conditions).

Routine use of **Sunburst** equipment can reduce or even eliminate shoulder pulling and blading operations required for removing unwanted weed growth.

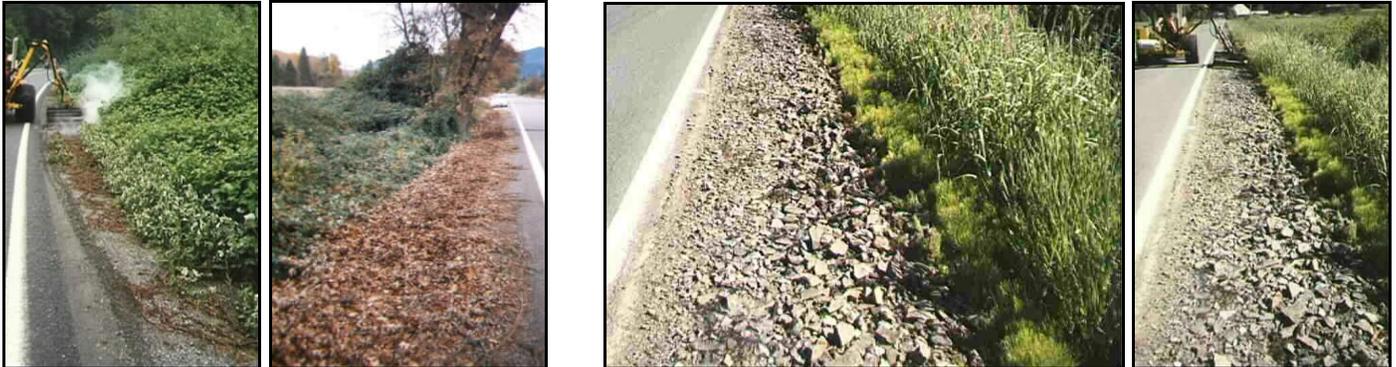
6. **Below: Left:** (2 different sites, Williams, Oregon)) - blackberry on road shoulders being controlled with *Sunburst* equipment (left – 2<sup>nd</sup> treatment being applied, note: steam, dead canes from 1<sup>st</sup> treatment, and wilted canes from 2<sup>nd</sup> treatment; right – 10 days after 1<sup>st</sup> treatment, dead canes lying on road shoulder). (Ave. rainfall <20” per yr.)

**Right:** (same site, Triangle Lake, Oregon): effective *control* of Horsetail (resprouts after 1<sup>st</sup> year of treatment were weak and very slender in diameter; resprouts in 2<sup>nd</sup> year were further reduced in number, size and vigor). Only 4 out of 8 planned *broadcast* treatments were applied to this road shoulder during the first year because control was so effective. Likewise, only 3 *broadcast* treatments were implemented in the 2<sup>nd</sup> year. All subsequent treatments (as required by the project protocol) were limited to scattered spot applications where weak sprouts were observed. (Ave. rainfall +/- 60” per yr.)

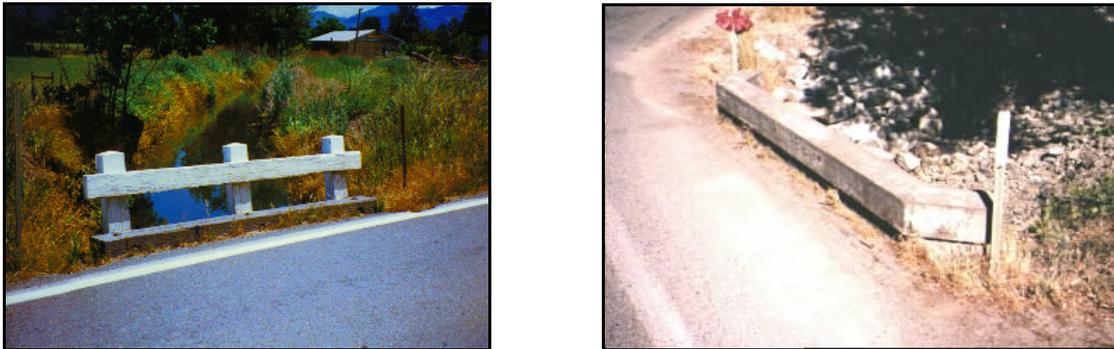
7. **Below:** Bridges – Sensitive Areas (between Williams and Grants Pass, Oregon). (Both sites: <20” of annual rainfall.)

a. **Left:** weed growth along railing controlled with 2 applications of *Sunburst* equipment. (Note herbicide use along irrigation channel).

b. **Right:** weeds on road shoulder and in front of concrete curbing controlled using 2 applications of *Sunburst* equipment.

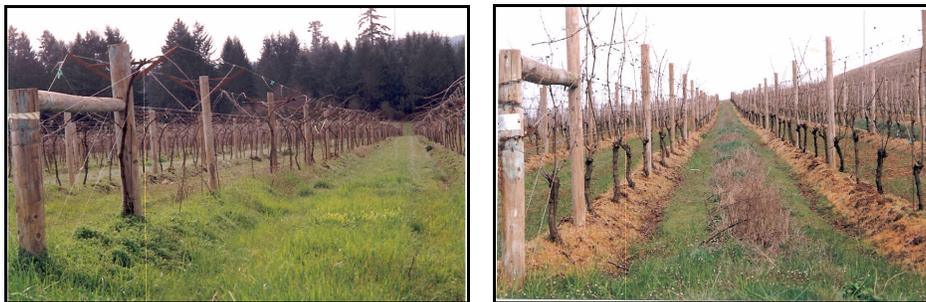
8. **Below:** Vineyard (south of Eugene, near Lorane, Oregon). (Ave. rainfall +/- 40” per yr.)

**Left:** before treatment (Spring season). **Right:** About 10 days following 1<sup>st</sup> treatment. Berms along the vine rows also annually treated with a “spider”-type tilling implement.
